Shipboard Exposure Testing of Aircraft Materials

Edwin S. Tankins*, J. Kozol & E. Lee

A study was performed comparing the corrosion resistance of various aluminum alloys in shipboard environments with an accelerated laboratory corrosion test environment. An Al-Li access panel for the F/A-18 was also tested. For comparison 7075 aluminum alloys were tested in the exfoliation susceptible T651 and the resistant T7351 temper.

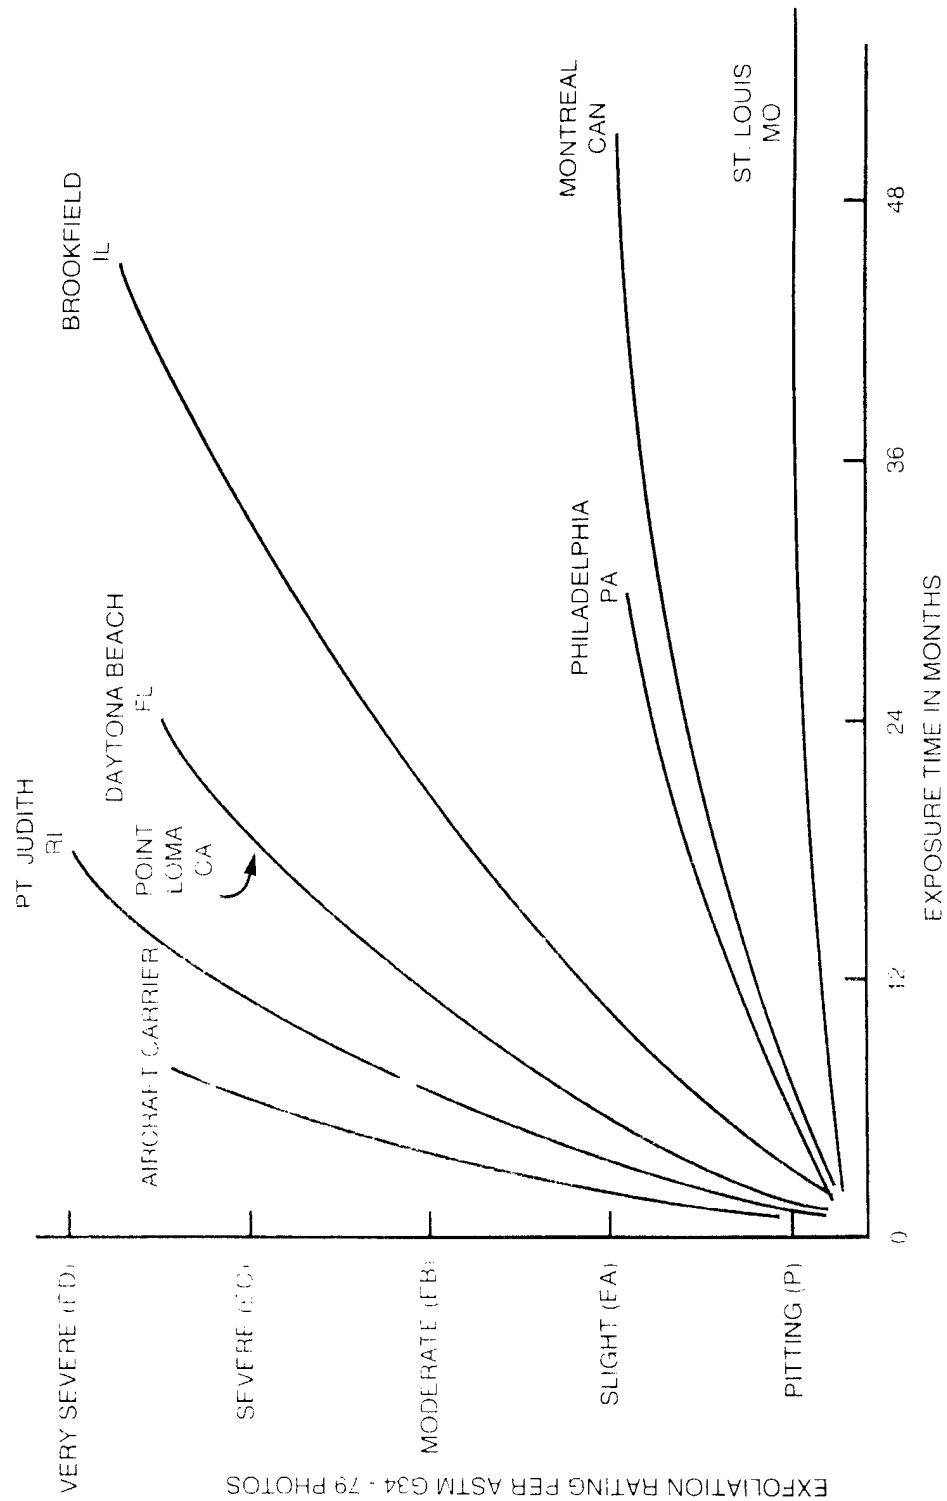
The study of various alloys included exposure aboard aircraft carriers as part of a series of exposures for the last ten years. Figure 1 summarizes the results of previous testing and shows that the carrier environment is more severe than seacoast or industrial environments (2). However, large differences exist between theaters of operations. Environmentally, the Indian Ocean deployment during the monsoon season is far more severe than the Atlantic or Mediterranean Sea deployment from which previous comparisons were made. Susceptible aluminum exposed aboard nuclear powered carriers (no stack gases) exhibited behavior similar to that aboard conventionally powered carriers (stack gases with jet engine

There has been considerable testing performed in various locations. There are pronounced differences in locations and environments. For instance, the Indian Ocean during the monsoon appears to be more severe than the Atlantic or Pacific. The work of Ketchum, et al (2) showed a comparison of the various environments. Figure 1 was first shown in their work (2) and is an excellent comparison.

Fig. 1 - Comparative corrosivity of natural environments
